VISUAL INSPECTION REPORT

Client : PT. Armada Gema Nusantara
Project Name : CMP Project
P.O. Number : 4500215518
Location : HCML FIELD MADURA Straits, East Java
Installation : FPSO KAS III
Date of Inspection : 2024-02-23
Report No : 20AGN22191410PP408
AG IRM Project No : 20AGN2219
Module : M35
Component ID : 1-AC110-59-IN-4258-V
Component Type : Piping
Material : PIPE SMLS A106 Gr B
Design Temperature : 65
Operating Temp : AMB
Design Pressure : 10 Barg
Operating Pressure : 5-7 Barg
Rep Line : No
Corrosion Loop : 059-IN/UN-C
Line From : 1-AC110-59-IN-4267-V
Line To : HP FLARE HEADER PURGE GAS
P&ID : 21022-BAE-75900-PR-DW-1003 / 71700-PR-DW-0002

1-AC110-59-IN-4258-V

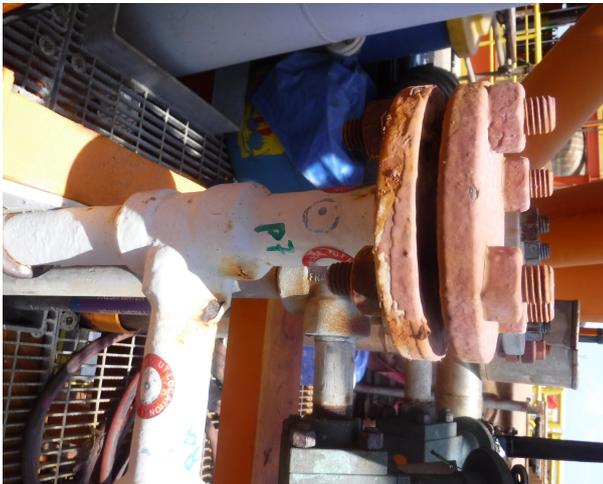
Fig. 1

Algae indicate on bolt and stud

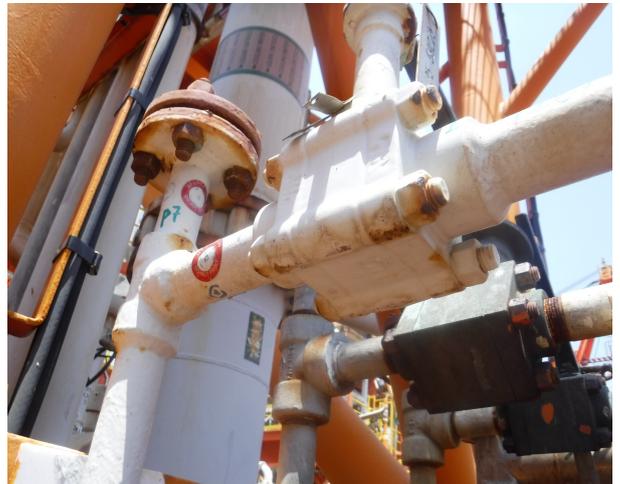
Fig. 2

Algae indicate on elbow

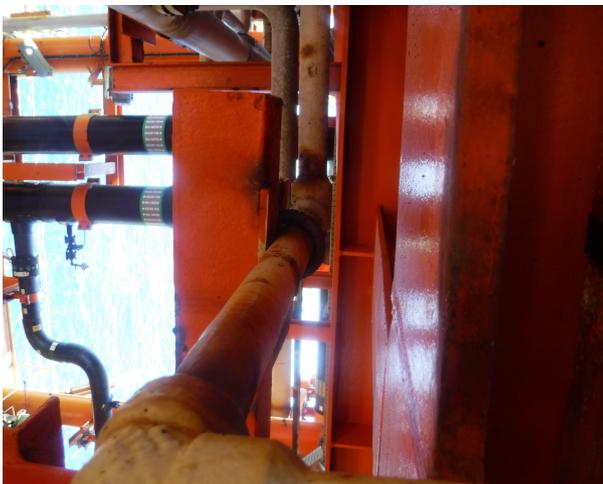
Fig. 3

Algae indicate on support

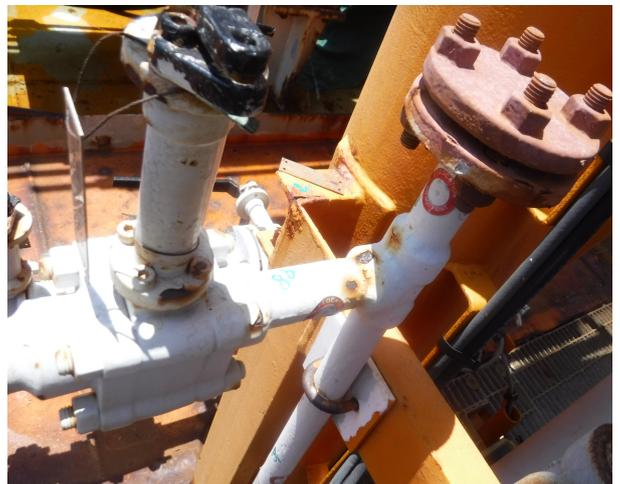
Fig. 4

Algae indicate on support

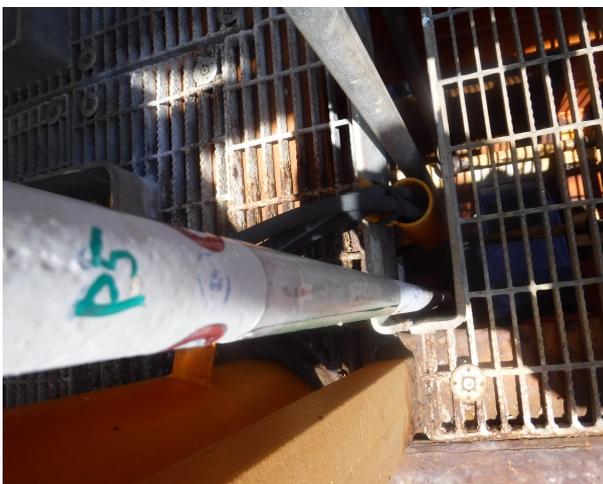
Fig. 5

Damaged on reducer

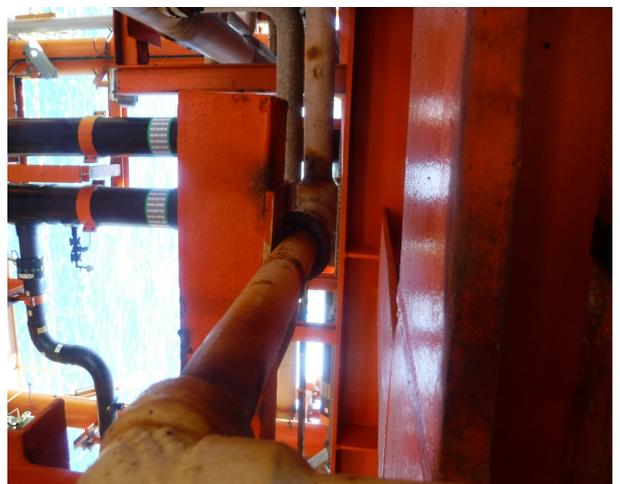
Fig. 6

Algae indicate on elbow

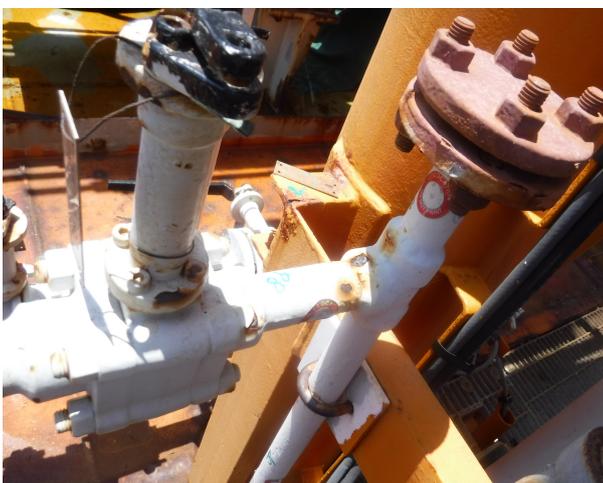
Fig. 7

Coating damage on flange

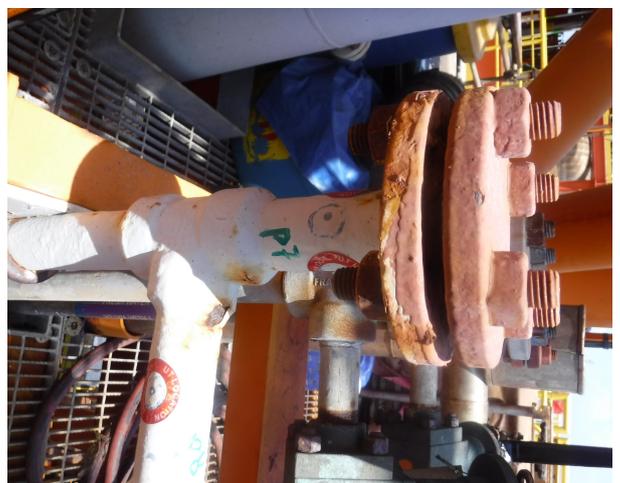
Fig. 8

Algae indicate on bolt and stud

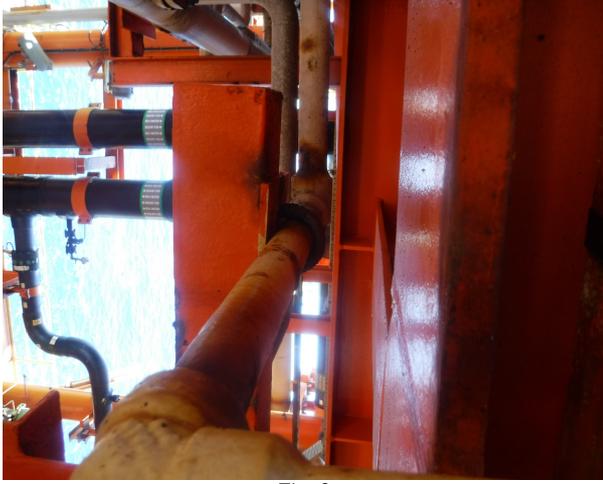
Fig. 9

Algae indicate on reducer

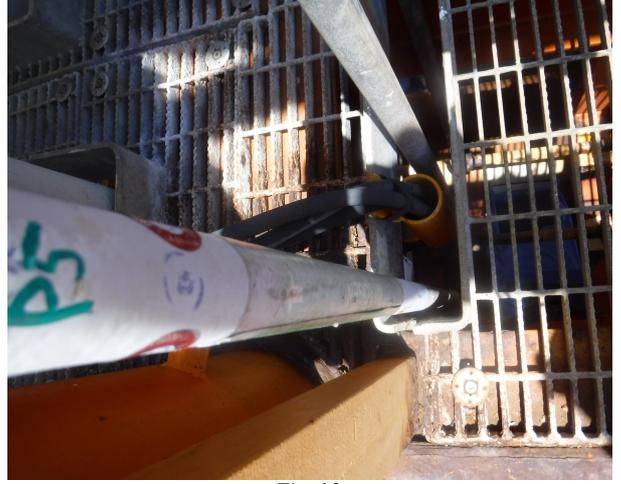
Fig. 10

Damaged on flange
