VISUAL INSPECTION REPORT

Client : PT. Armada Gema Nusantara
Project Name : CMP Project
P.O. Number : 4500215518
Location : HCML FIELD MADURA Straits, East Java
Installation : FPSO KAS III
Date of Inspection : 2023-11-27
Report No : 20AGN22191410PP378
AG IRM Project No : 20AGN2219
Module : M35
Component ID : 1-AC110-59-IN-4287-V
Component Type : Piping
Material : PIPE SMLS A106 Gr B
Design Temperature : 65
Operating Temp : AMB
Design Pressure : 10 Barg
Operating Pressure : 5-7 Barg
Rep Line : No
Corrosion Loop : 059-IN/UN-C
Line From : 2-AC110-59-IN-4260-V
Line To : UTILITY HOSE CONNECTION
MODULE-35
P&ID : 21022-BAE-75900-PR-DW-1003

1-AC110-59-IN-4287-V

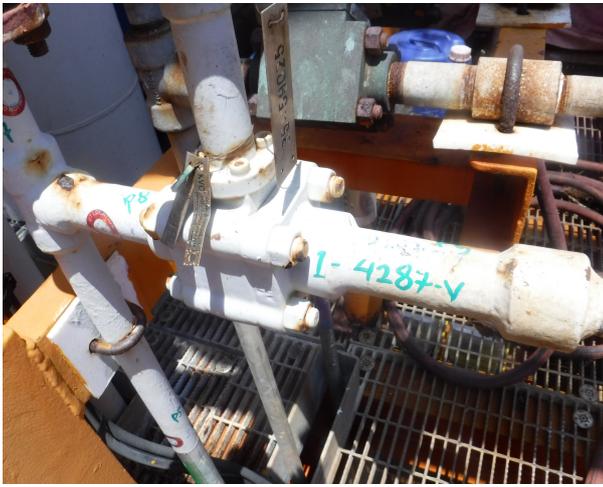
Fig. 1

General view

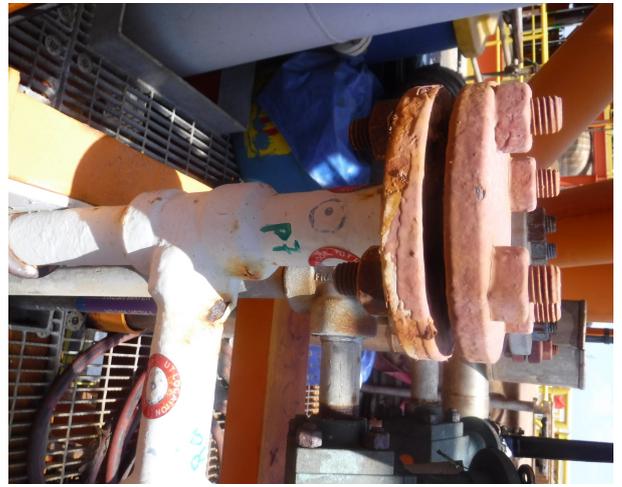
Fig. 2

Corroded on valve

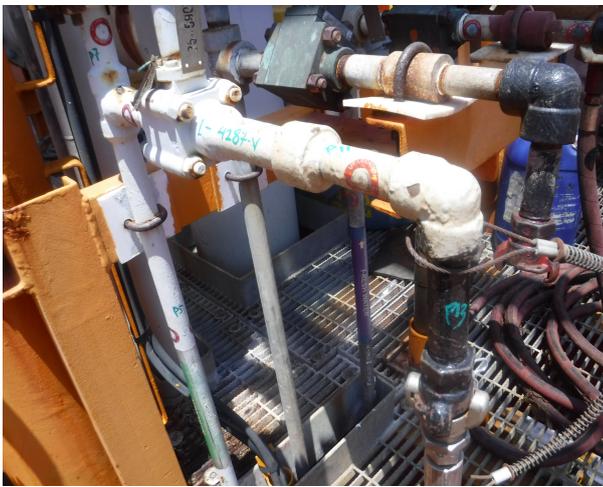
Fig. 3

Corroded on pipe

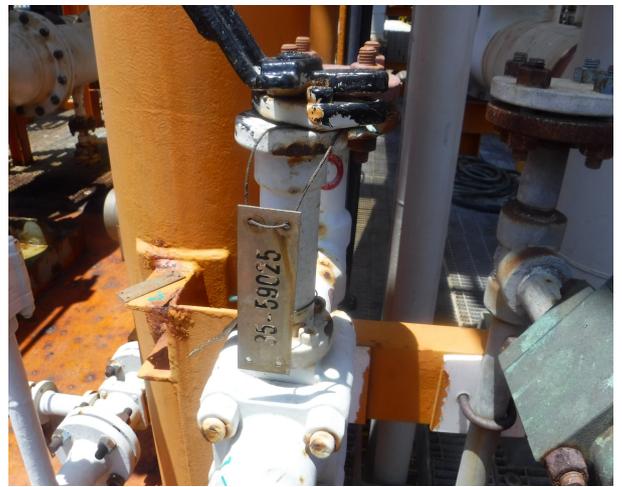
Fig. 4

Surface corrosion on pipe

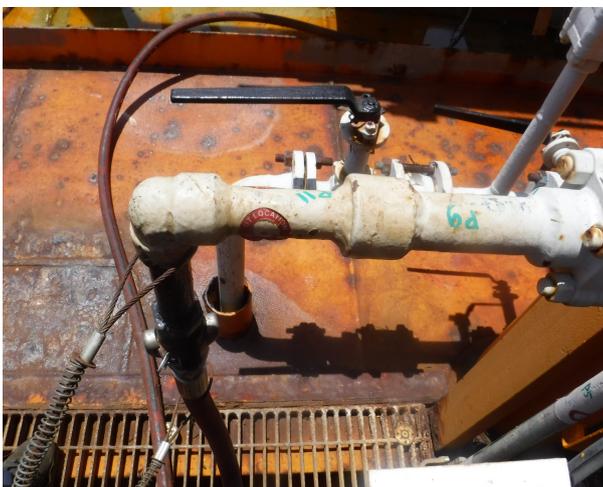
Fig. 5

Surface corrosion on reducer

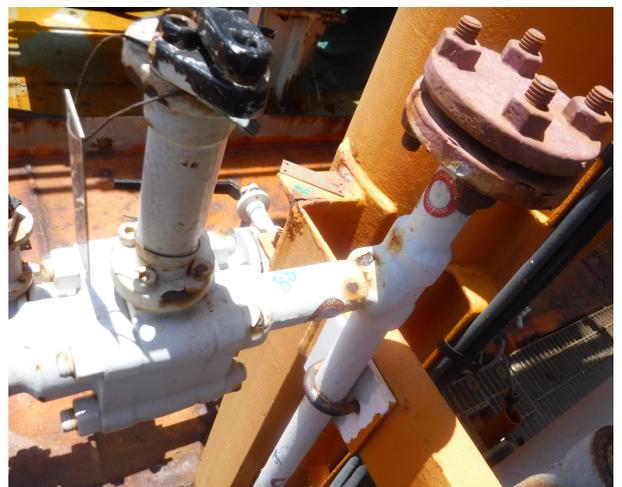
Fig. 6

Surface corrosion on elbow

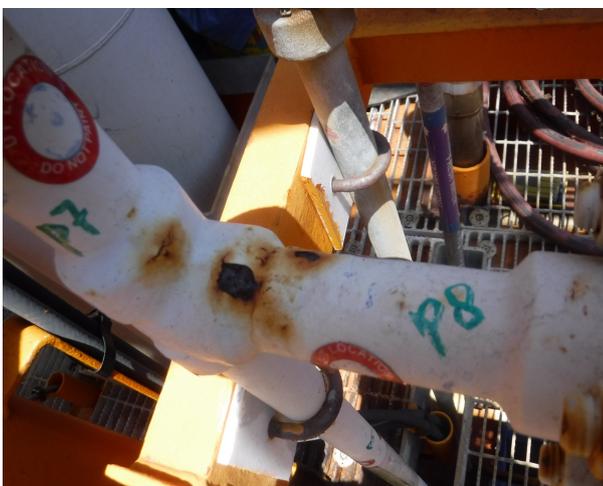
Fig. 7

Good condition

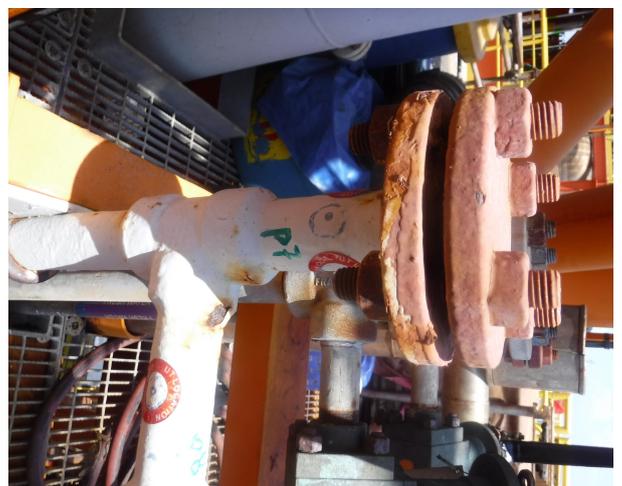
Fig. 8

Surface corrosion on flange

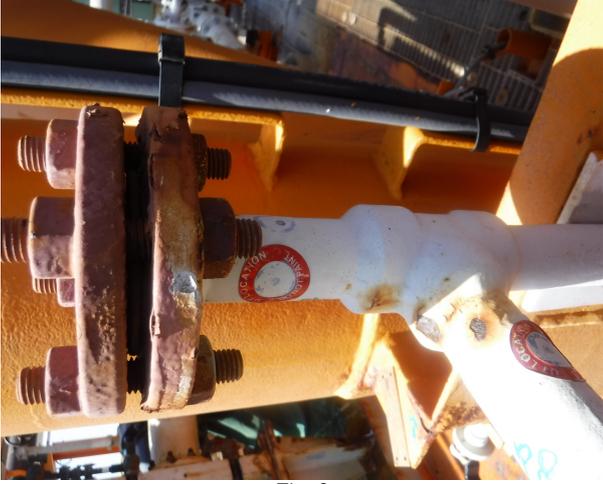
Fig. 9

Good condition

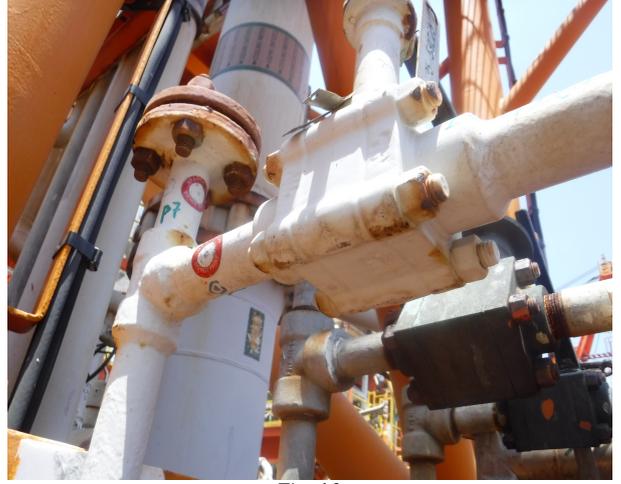
Fig. 10

Corroded on support

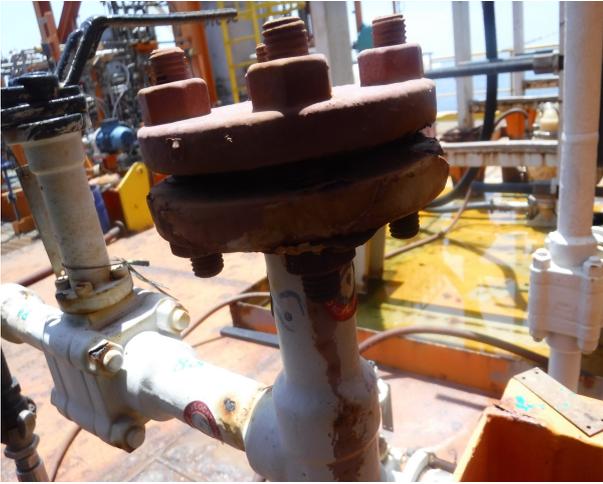
Fig. 11

Surface corrosion on pipe

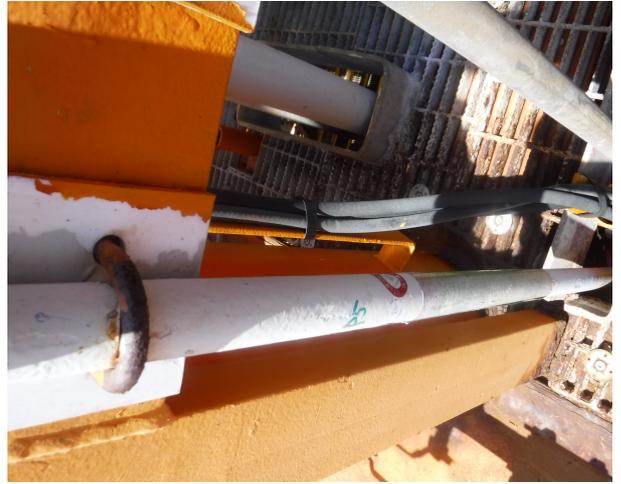
Fig. 12

Corroded on support

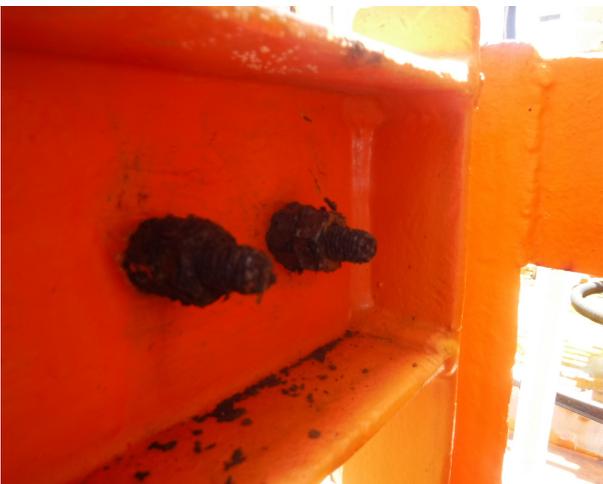
Fig. 13

Surface corrosion on bolt and stud

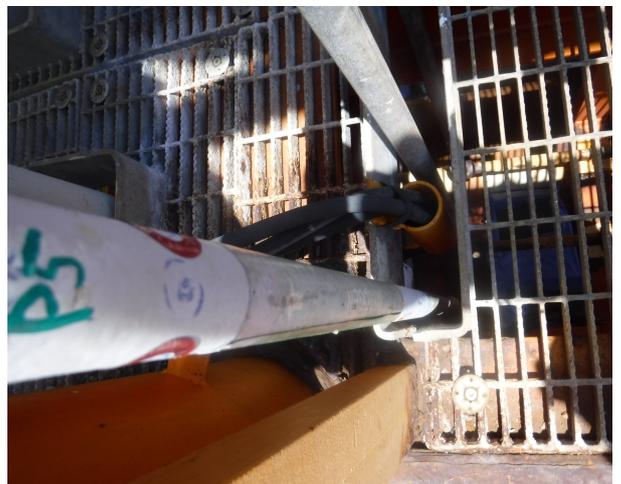
Fig. 14

Surface corrosion on reducer

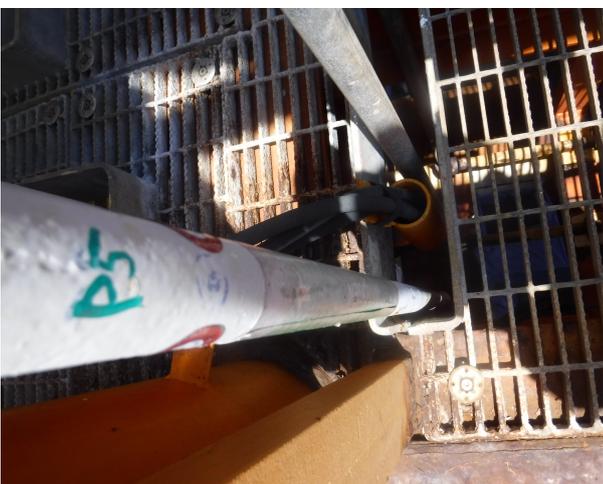
Fig. 15

Surface corrosion on elbow

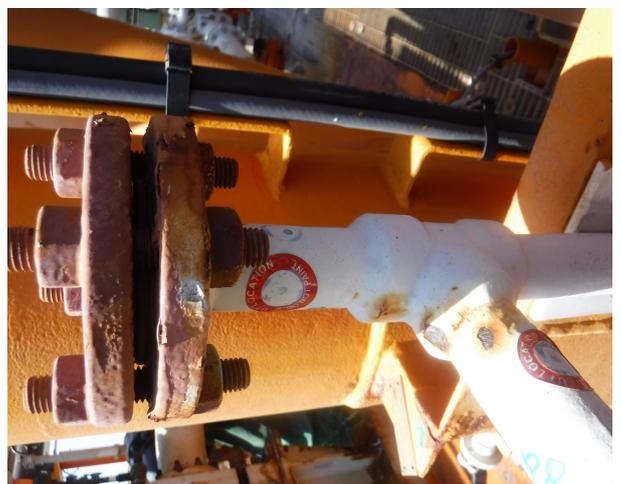
Fig. 16

Surface corrosion on elbow

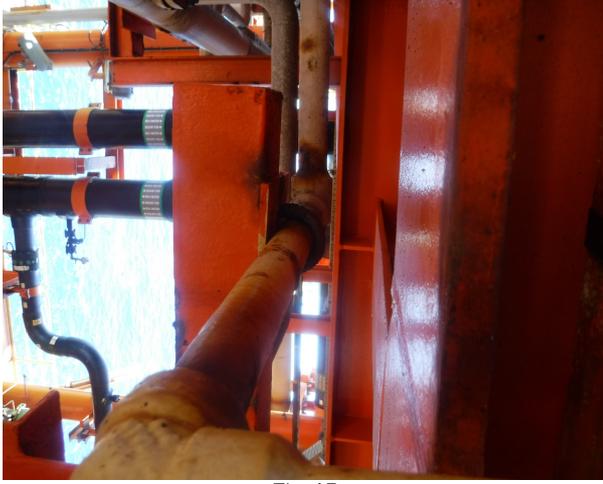
Fig. 17

Metal loss on pipe

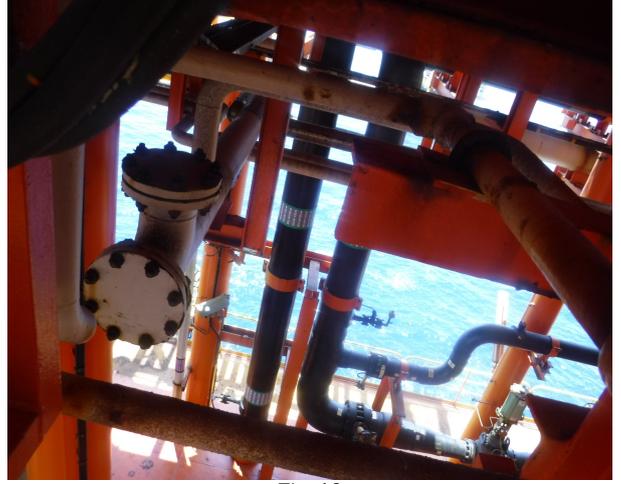
Fig. 18

Algae indicate on flange

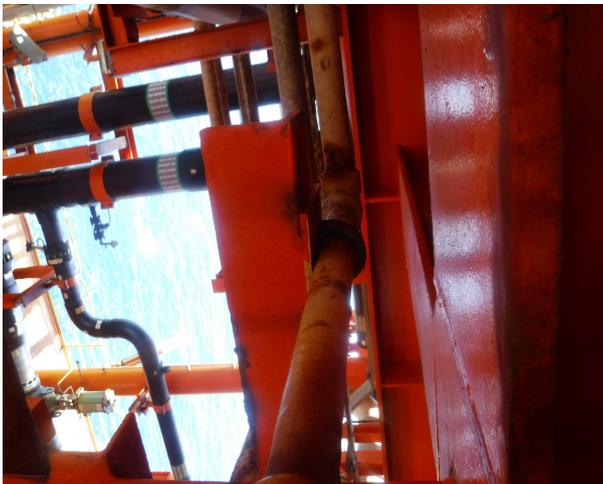
Fig. 19

Surface corrosion on bolt and stud

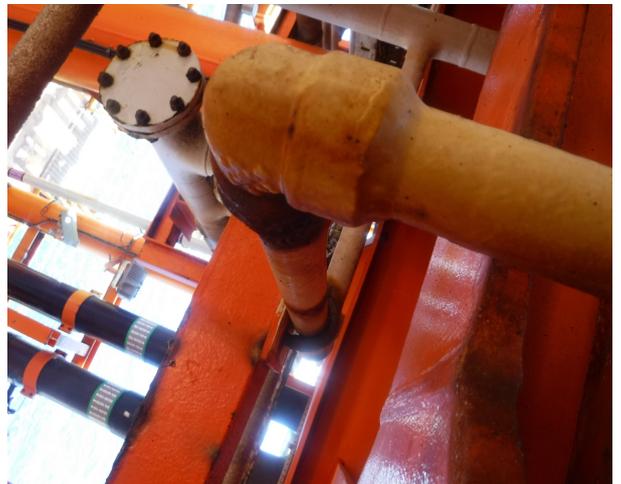
Fig. 20

Leaking on valve

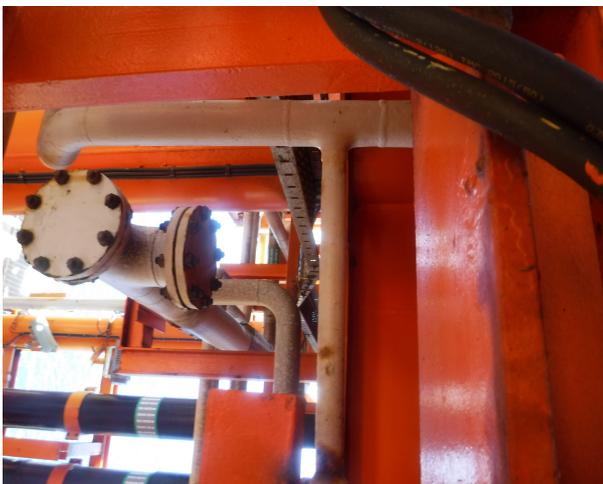
Fig. 21

Surface corrosion on pipe
