VISUAL INSPECTION REPORT

Client : PT. Armada Gema Nusantara
Project Name : CMP Project
P.O. Number : 4500215518
Location : HCML FIELD MADURA Straits, East Java
Installation : FPSO KAS III
Date of Inspection : 2024-02-23
Report No : 20AGN22191410PP384
AG IRM Project No : 20AGN2219
Module : M35
Component ID : 2-AC111-56-UA-4138-N
Component Type : Piping
Material : PIPE SMLS A106 Gr B
Design Temperature : 120
Operating Temp : AMB
Design Pressure : 10 Barg
Operating Pressure : 5 - 7 Barg
Rep Line : No
Corrosion Loop : 053-IA/UA-C
Line From : UTILITY DISTRIBUTION HEADER (MARINE PIPE RACK)
Line To : MODULE-35 UTILITY AIR SUPPLY (FLANGED)
P&ID : BAE-50120-PR-DW-0001

2-AC111-56-UA-4138-N

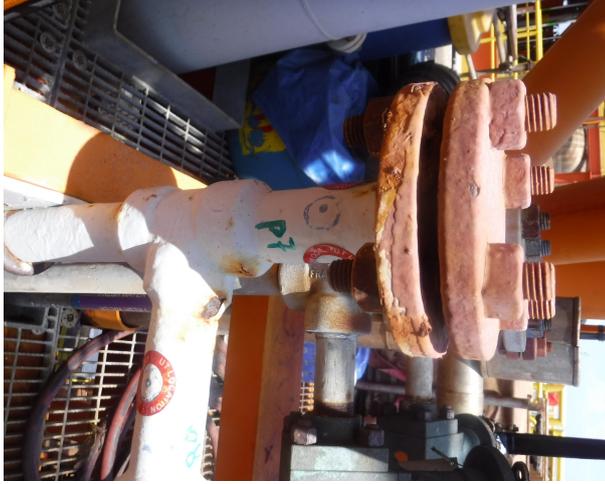
Fig. 1

Surface corrosion on valve

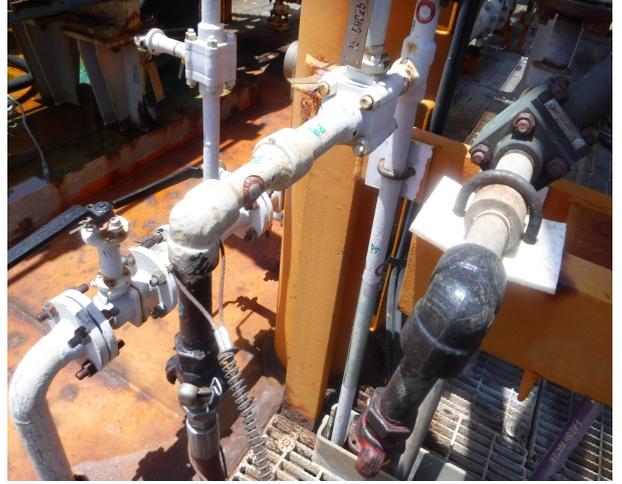
Fig. 2

Surface corrosion on support
