VISUAL INSPECTION REPORT

Client : PT. Armada Gema Nusantara	Material : PIPE SMLS A106 Gr B
Project Name : CMP Project	Design Temperature : 107,2
P.O. Number : 4500215518	Operating Temp : 40-44
Location : HCML FIELD MADURA Straits, East Java	Design Pressure : 92,4 Barg
Installation : FPSO KAS III	Operating Pressure : 83 Barg
Date of Inspection : 2024-04-11	Rep Line : No
Report No : 20AGN22191410PP383	Corrosion Loop : 010-CO-C-IN
AG IRM Project No : 20AGN2219	Line From : CONDENSATE RECYCLE PUMP30-PC-3721A/B (TP-04B)
Module : M30	Line To : 2-DC220-37-CO-1049-E
Component ID : 2-DC220-37-CO-1050-E	P&ID : 21022-BAE-73700-PR-DW-0011 (Sht 2)
Component Type : Piping

2-DC220-37-CO-1050-E

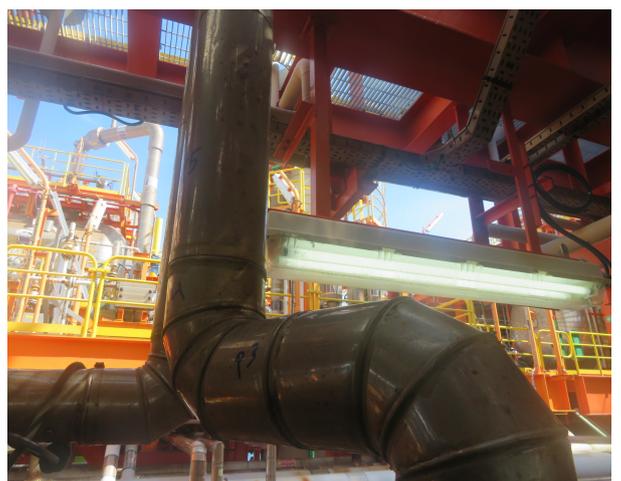
Fig. 26

Galvanic corrosion on reducer at P1,P2,E3
