VISUAL INSPECTION REPORT

0,5-AC220-64-DS-4803-V

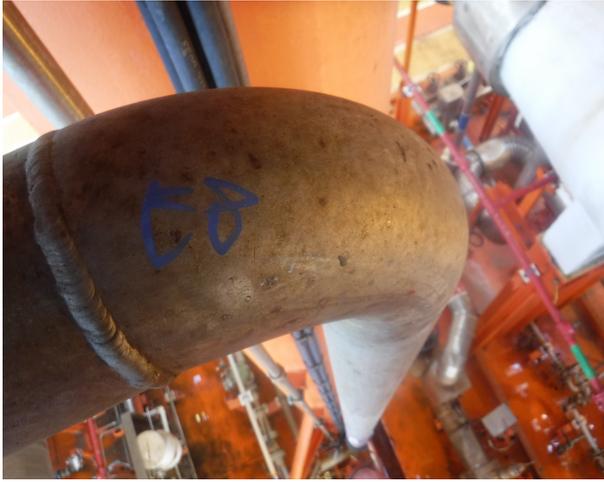
Fig. 1

Surface corrosion at P1,P2,E3

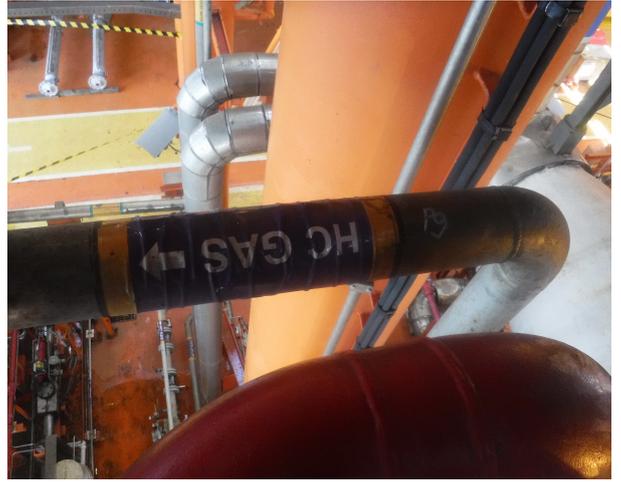
Fig. 2

Surface corrosion rekomen to paint at P1,P2,E3

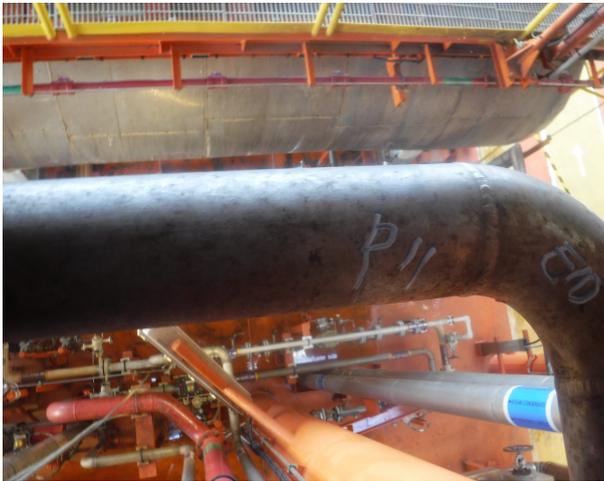
Fig. 3

Surface corrosion at P1,P2,E3

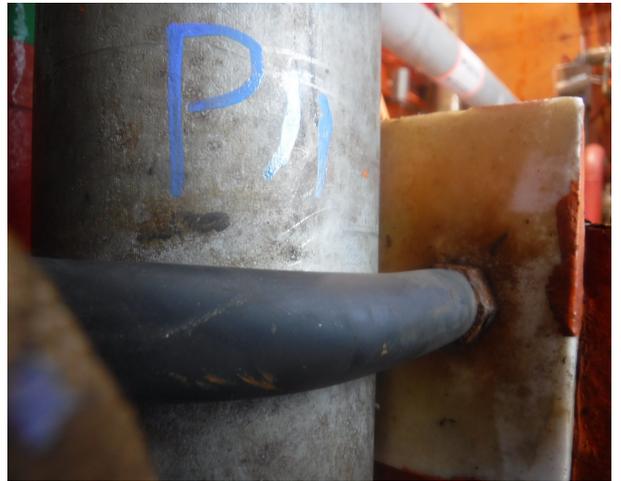
Fig. 4

Surface corrosion at P1,P2,E3

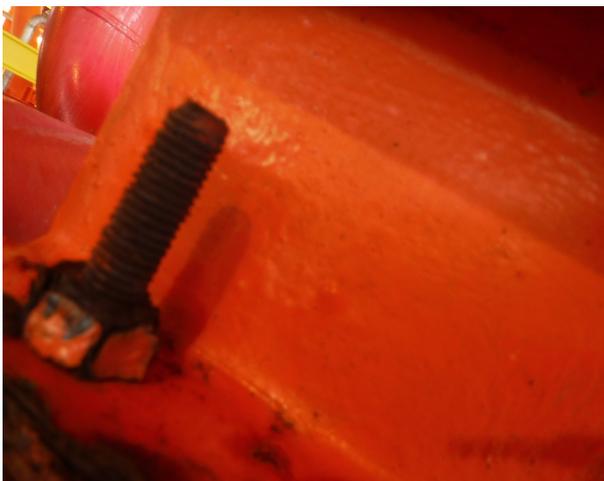
Fig. 5

Surface corrosion at P1,P2,E3

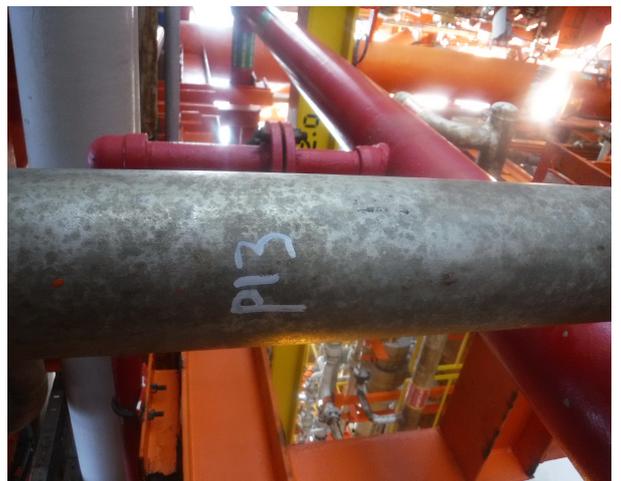
Fig. 6

Surface corrosion at P1,P2,E3

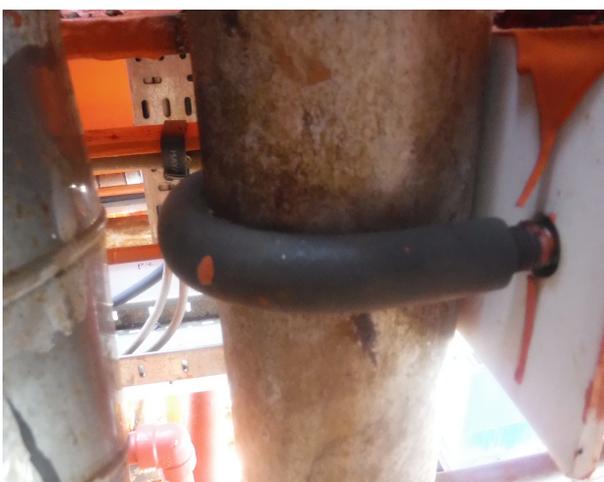
Fig. 7

Surface corrosion at P1,P2,E3

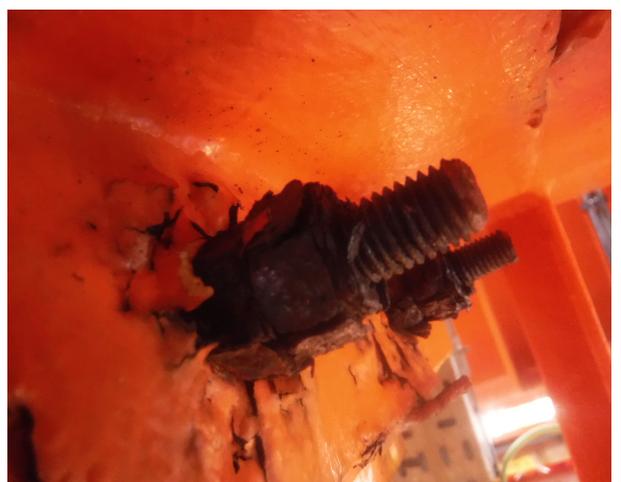
Fig. 8

Surface corrosion at P1,P2,E3

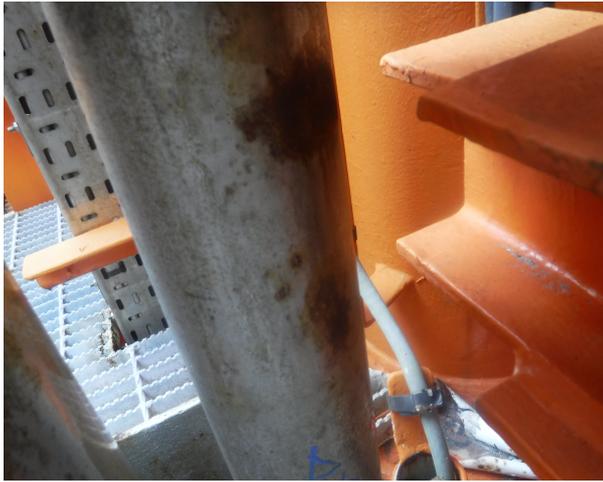
Fig. 9

Surface corrosion at P1,P2,E3

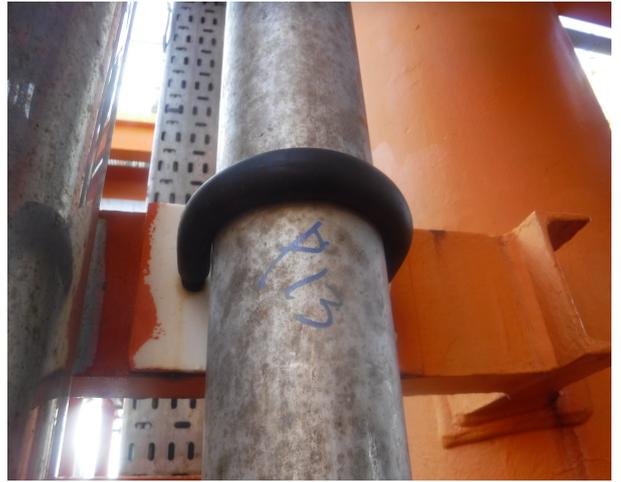
Fig. 10

Surface corrosion at P1,P2,E3
